**DEPARTMENT OF TRANSPORTATION****DIVISION OF ENGINEERING SERVICES**

Contract #: 04-0120F4Cty: SF/ALA Rte: 80 PM: 13.2/13.9File #: 13.28**WELDING INSPECTION REPORT****Resident Engineer:**Pursell, Gary**Address:** 333 Burma Road**City:** Oakland, CA 94607**Report No:** WIR-010015**Date Inspected:** 04-Nov-2009**Project Name:** SAS Superstructure**OSM Arrival Time:** 700**Prime Contractor:** American Bridge/Fluor Enterprises, a JV**OSM Departure Time:** 1530**Contractor:** Oregon Iron Works Clackamas, Or.**Location:** Clackamas, OR

**Bridge No:** 34-0006**Component:** Hinge K Pipe Beams**Summary of Items Observed:**

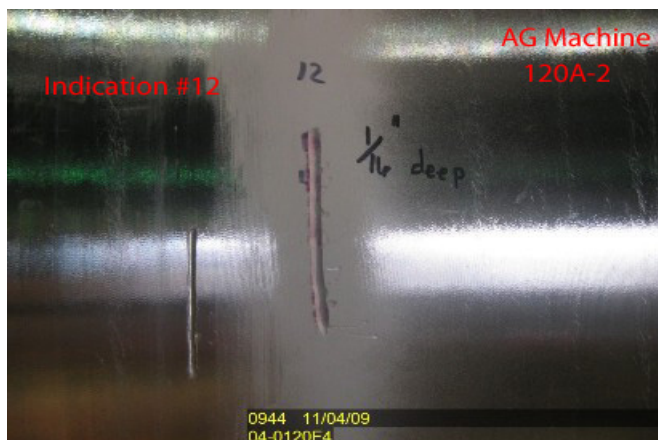
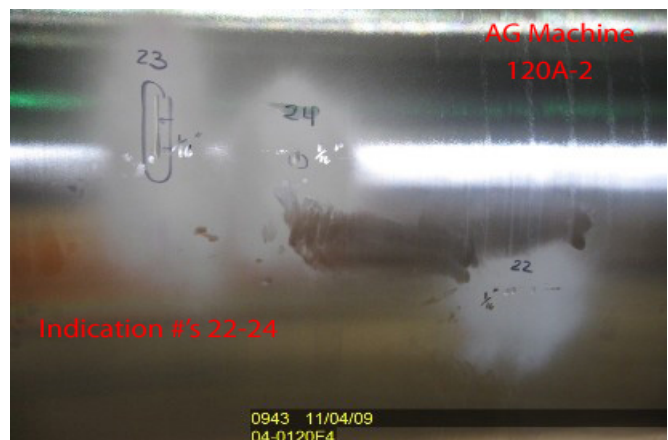
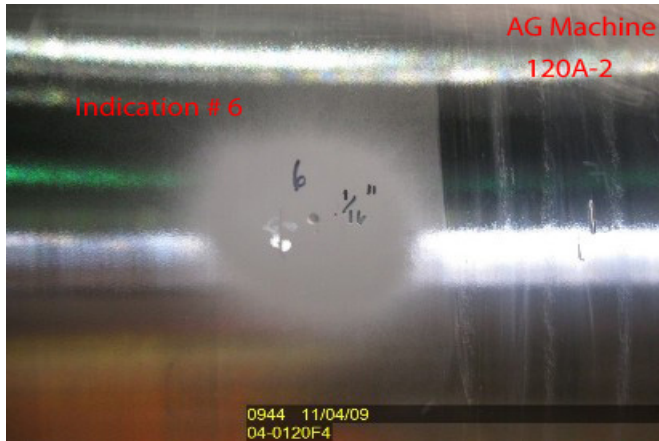
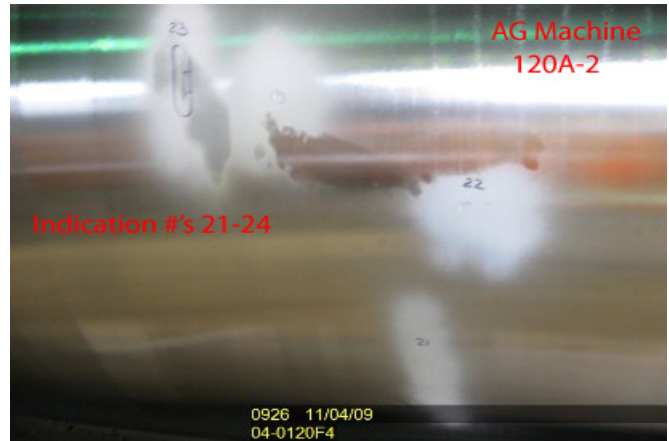
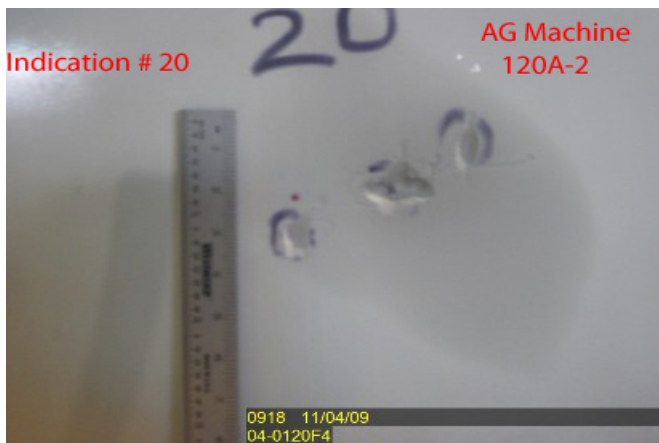
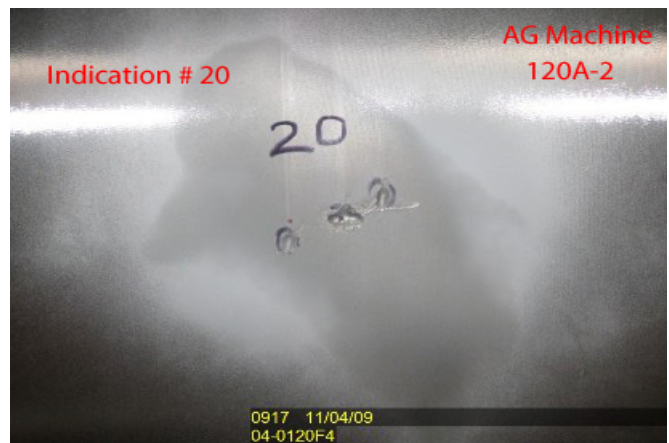
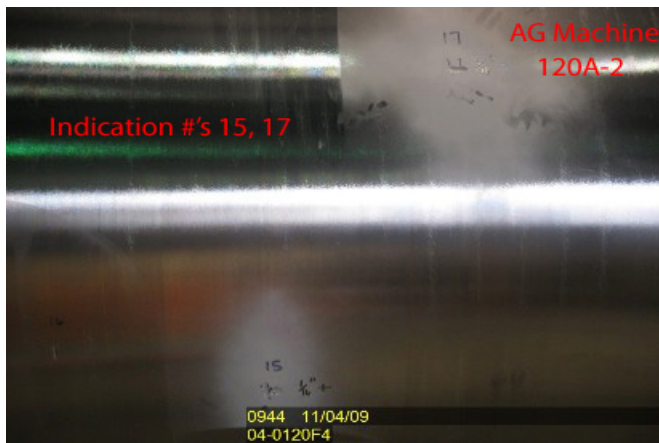
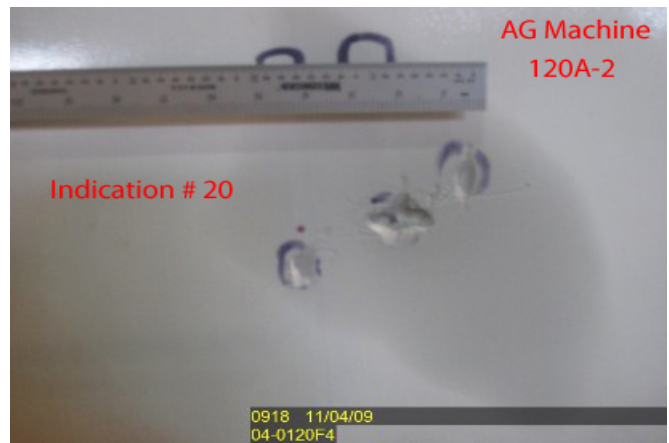
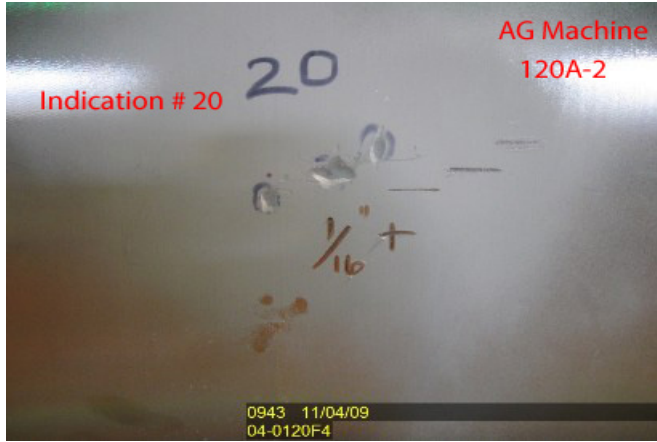
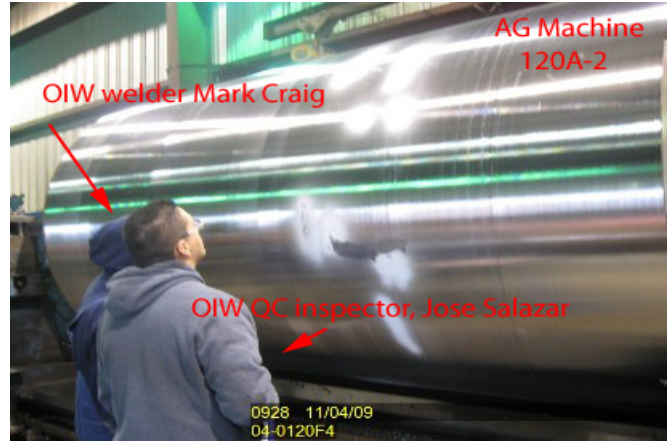
QA Inspector was informed, by Mr. Salazar, that QCM Tomovick explained to Mr. Salazar, that all excavation depths that exceeded 1/32" (.6mm), will be a weld repair and the excavations less that this depth, will be machined out, during final machining. QA Inspector noted that this would be a total of 8 excavations and that Mr. Craig was ready to begin welding on these excavations, utilizing welding procedure specification, (WPS 8022) and that the fuse assembly 120A-2 was currently rotated in the horizontal lathe, so the 1st indication repair, would be performed in the flat position, utilizing the gas tungsten arc welding process (GTAW), per the applicable WPS 8022. QA Inspector noted that prior to performing the GTAW, Mr. Craig had applied pre-heat to the weld repair area and surrounding heat affected zone/base metal and QC Inspector Jose Salazar had recorded a pre-heat temperature of 150 degrees Fahrenheit (65 Celsius), utilizing a digital thermometer. QA Inspector noted that Mr. Craig had then started the GTAW and QA Inspector witnessed Mr. Salazar performing in-process welding parameters and recording amperage of 121 amps and voltage of 15.1 volts. QA Inspector verified that these in-process welding parameters, were in compliance with WPS 8022. QA Inspector noted that Mr. Craig had soon completed the GTAW repair on the first excavation and had started the GTAW on the next 7 excavations, measuring depths greater than 1/32" (.6mm). QA Inspector noted that the excavations, prior to welding, were rotated to the flat position, in the horizontal lathe and QA Inspector witnessed QC Inspector Jose Salazar performing temperature checks on the areas and surrounding base metal and noted that the pre-heat was approximately 160 degrees Fahrenheit (71 Celsius). QA Inspector witnessed Jose Salazar performing and recording in-process welding parameters averages of 125 amps and 15.2 volts, which is in accordance to the applicable WPS 8022. QA Inspector noted that Mr. Craig had completed the weld repairs at approximately 1100 and QC Inspector Jose Salazar explained that once the repair areas cool to ambient temperature, 100% informational penetrant testing will then be performed, on the repairs. QA Inspector later witnessed Mr. Salazar performing the penetrant testing and noted that no rejectable indications were found, per AWS D1.5. QA Inspector noted that the above mentioned weld repairs that were performed by OIW personell at AG Machine shop, appeared to be in compliance with the applicable WPS 8020 and contract requirements. See attached pictures below.

Note: QA Inspector noted that the above mentioned indications appeared to be small, circular slag inclusions that were deposited during the electroslog overlay welding process performed by OIW.
